Vossloh RailWatch GmbH

Pulsar & MicroPulsar

in comparison

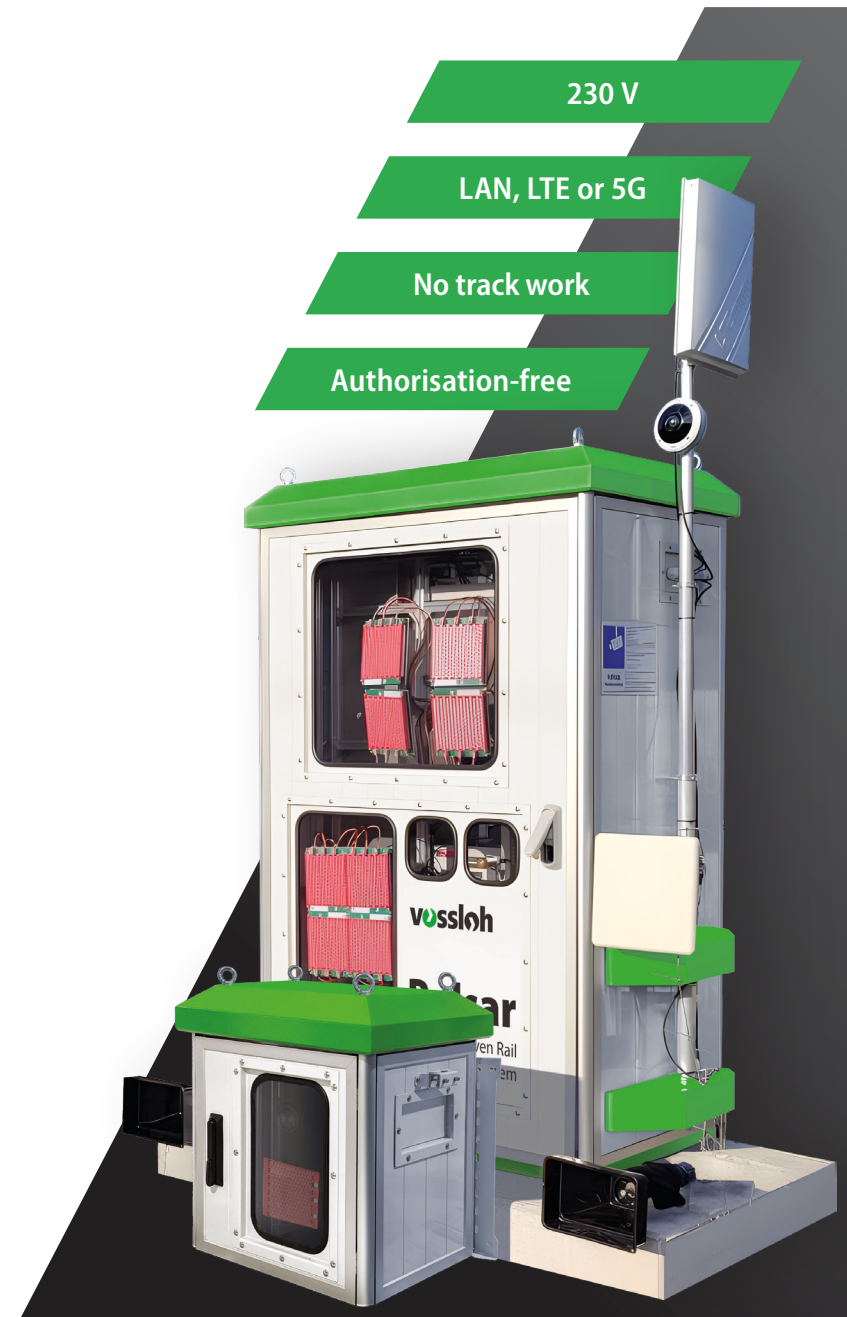
MicroPulsar

Pulsar

70 cm x 80 cm x 60 cm

Dimensions (WxHxD)

125 cm x 200 cm x 85 cm

The dimensions refer to the housing and do not include the following attachments: LTE antenna, RFID reader and microphones.

Track distance up to 4 m. Can be set up almost anywhere thanks to its space-saving format.

Track distance up to 8 m.
Foundation of 2m² necessary.

The MicroPulsar is ideal when it comes to optimizing incoming goods inspection and other internal processes. Thanks to its slim and compact size, it can be installed almost anywhere next to the infrastructure.

The Pulsar can be used for both, process optimization, e.g. in the area of incoming goods, as well as for the optimization of maintenance processes with the help of condition data.

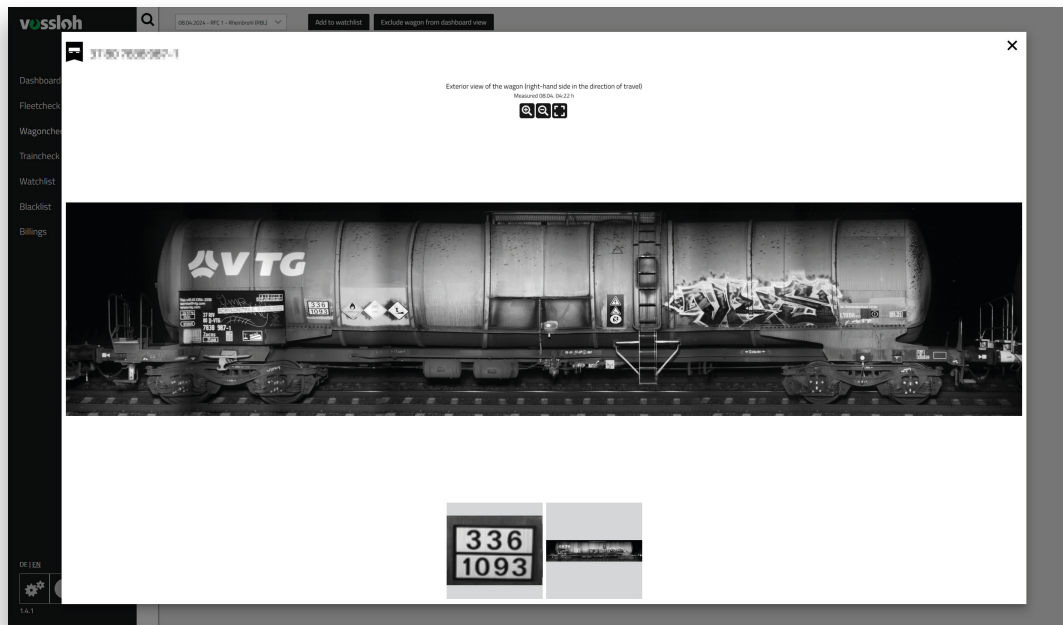
◀ Exterior view

The detailed exterior view of the wagon, based on high-resolution images, allows you to check the external condition of the wagon.

The detailed exterior view of the wagon, based on high-resolution images, allows you to check the wagon for external damage. Depending on the wagon type, you can also determine which kind of cargo is on the wagon.
